RAILROAD ACCIDENT REPORT

HAZARDOUS MATERIALS ACCIDENT
IN THE RAILROAD YARD OF THE
NORFOLK AND WESTERN RAILWAY AT
DECATUR, ILLINOIS
JULY 19, 1974

NATIONAL TRANSPORTATION SAFETY BOARD
Washington, D.C. 20594
REPORT NUMBER: NTSB-RAR-75-4

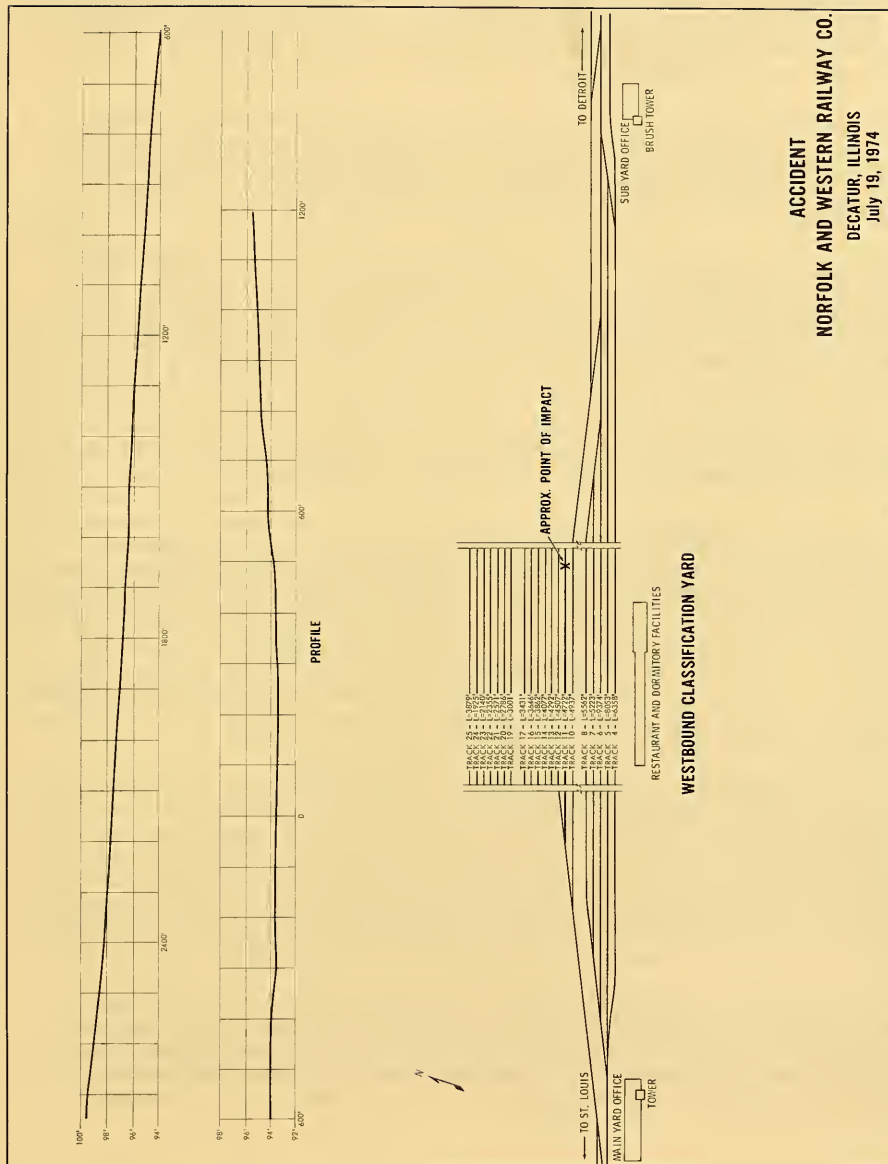
Figure 1. Plan view of portion of Westbound Yard.

Yard Location and Site -- N&W's Decatur yard is located on the east side of the city. A service road, which runs east and west, divides the yard into an eastbound portion and a westbound portion. The general yard offices and East Decatur Tower are located at the west end of the westbound yard. Brush tower is located at the east end of the westbound yard. (See Figure 1.) A yardmaster is on duty in each of the towers 24 hours a day.
